**Flood Control Project Maintenance
Levee Inspections****2014 Channel Summary Report****Overall Unit and Item Ratings****DWR Sutter Maintenance Yard**

Flood Control Project Maintenance**Unit Cover Sheet****2014 Channel Inspection Results****DWR Sutter Maintenance Yard**

Channel
Big Chico Creek

Levee Inspection Report By Mile - Channel 2014

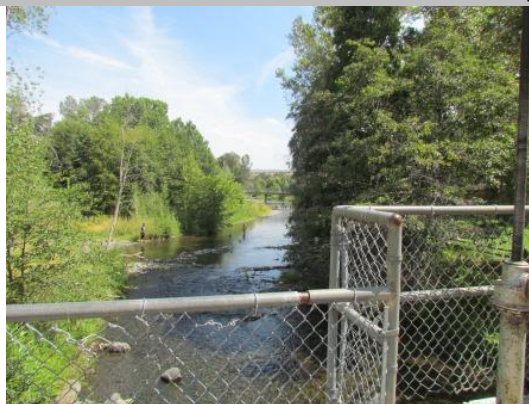
Photo 1 of 1 : CH_2014_NA0060_5_1_20140721_00013.jpg

Rating **	A	Issue No.	1	GPS Lat/Long
Issue Type +	Ma	Location *		39.761840 °
Category	Rivers, Channels & Designated Flood			-121.792590 °
Item	Vegetation & Obstructions			
DWR ID	DWR_NA0060_5_c_2012_1			
Action/Comments				
Inspector Comments: Minimal, scattered obstructions and vegetation. The flow is not impeded.

This is the upstream side of the structure.

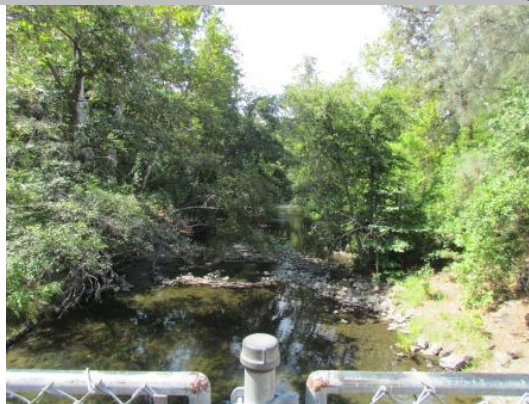
Photo 1 of 1 : CH_2014_NA0060_5_6_20140721_00014.jpg

Downstream side of the structure.

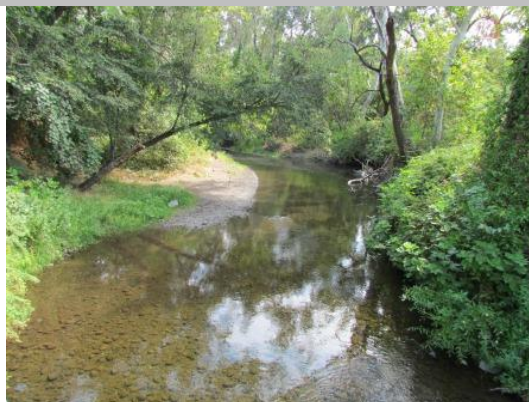
Photo 1 of 1 : CH_2014_NA0060_5_11_20140721_00015.jpg

This photo is looking upstream on Manzanita Ave.

Rating **	A	Issue No.	12	GPS Lat/Long
Issue Type +	Ma	Location *		39.758260 °
Category	Rivers, Channels & Designated Flood			-121.795380 °
Item	Shoaling / Sedimentation			
DWR ID	DWR_NA0060_5_c_2012_12			
Action/Comments				
Inspector Comments: Shoaling or sedimentation was observed. Does not seem to impede flow.

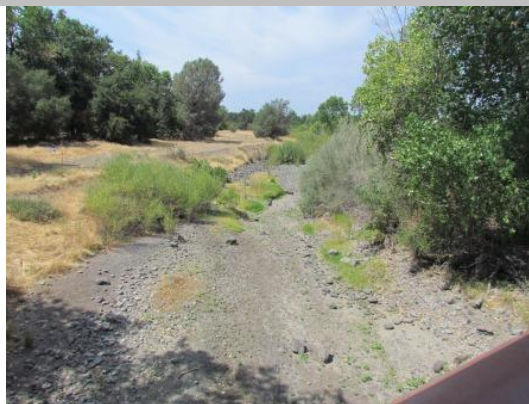
Photo 1 of 1 : CH_2014_NA0060_6_16_20140721_00027.jpg

This view is looking downstream from Manzanita Ave.

Rating **	A	Issue No.	18	GPS Lat/Long
Issue Type +	Ma	Location *		39.760510 °
Category	Rivers, Channels & Designated Flood			121.802070 °
Item	Erosion / Bank Caving			
DWR ID	DWR_NA0060_6_c_2012_18			
Action/Comments				
Inspector Comments: Some head cutting or horizontal deviation observed due to high water in past years.

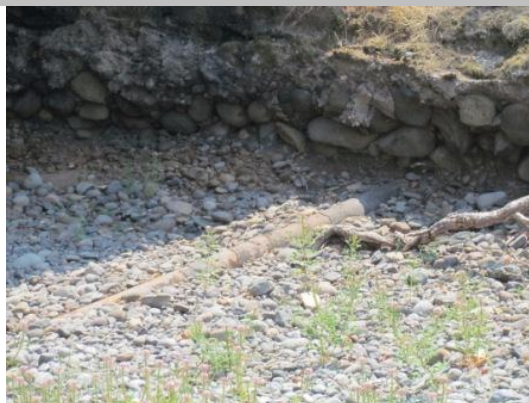
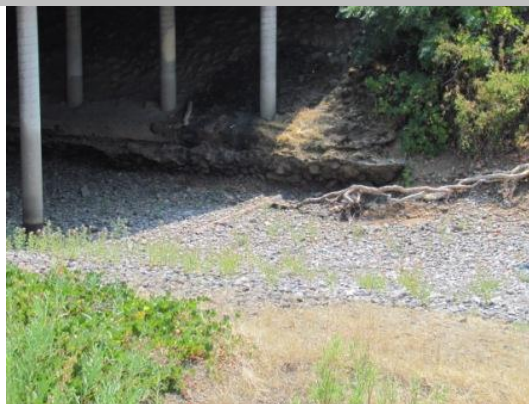
Erosion around bridge footing and south bank of channel.

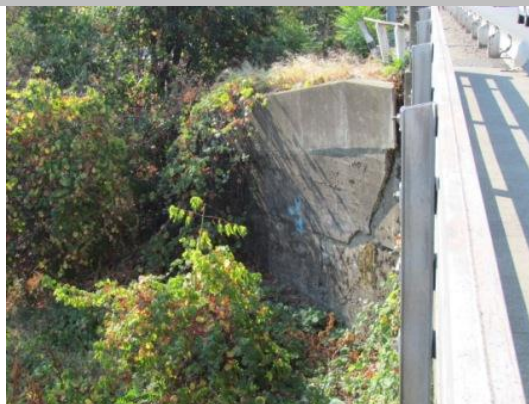
Photo 1 of 2 : CH_2014_NA0060_6_51_20140630_00013.jpg

Concrete cracking on south side wing wall upstream of Esplanade Ave.

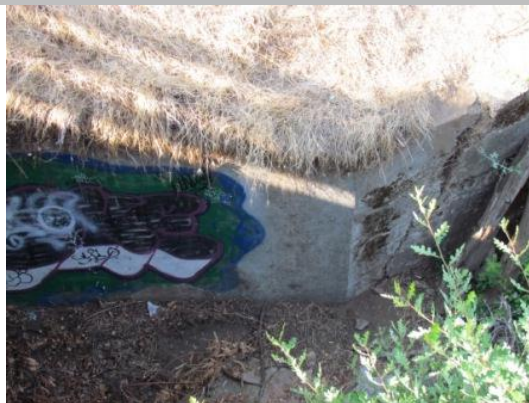
Photo 2 of 2 : CH_2014_NA0060_6_56_20140630_00016.jpg

Concrete cracking on south side wing wall downstream of Esplanade Ave.

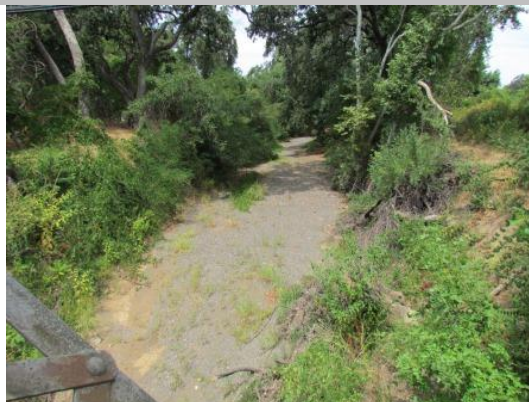
Photo 1 of 1 : CH_2014_NA0060_6_81_20140721_00039.jpg

Inspector Comments: Scattered obstructions and vegetation.

This photo is looking upstream at the channel from the Grape Way bridge.

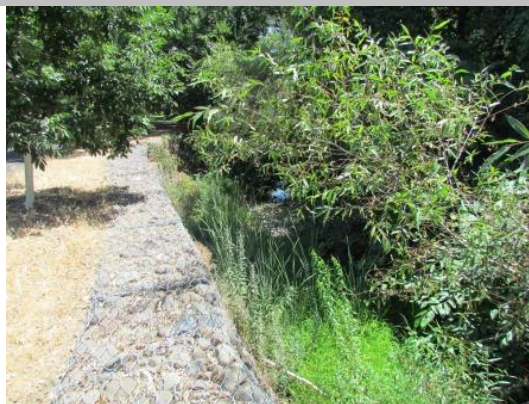
Photo 1 of 1 : CH_2014_NA0060_12_31_20140721_00023.jpg

This photo is looking upstream at the erosion repair site, up stream from Highway 99 on Humboldt Road. There is vegetation in the channel, the flow in the channel does not appear to be impeded.

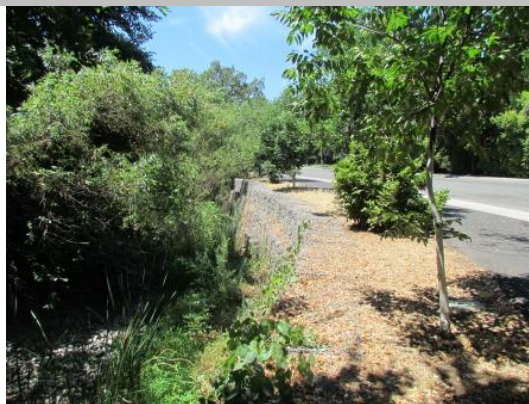
Photo 1 of 1 : CH_2014_NA0060_12_36_20140721_00024.jpg

This photo is looking upstream at the erosion repair site, up stream from Highway 99 on Humboldt Road. There is vegetation in the channel, the flow in the channel does not appear to be impeded.
